The Scourge of Yellow Brass in Plumbing Fittings

Is zinc in the brass fittings too much of a good thing?

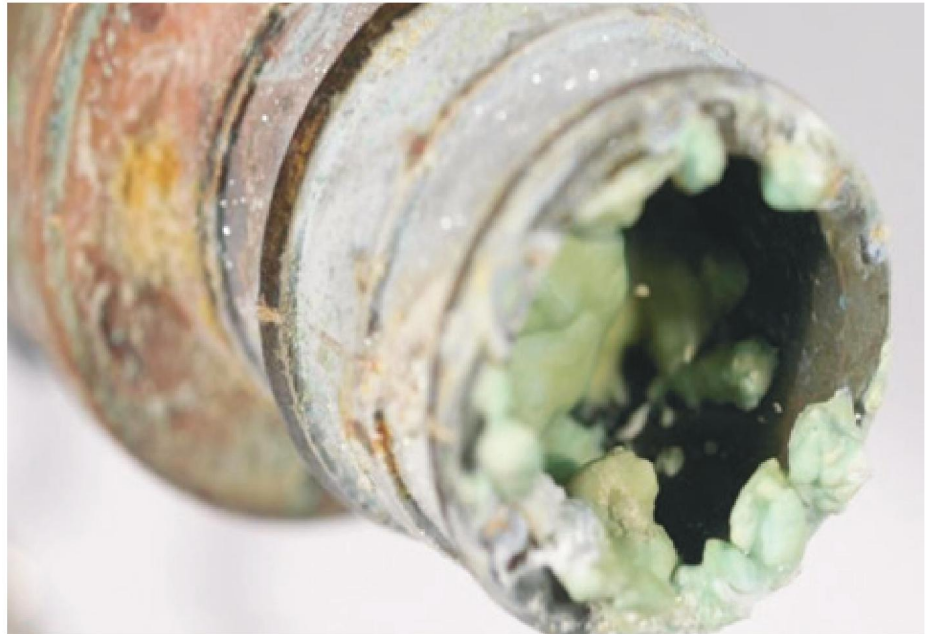
A PEX, yellow brass fitting, attaching the PEX tubing to a copper water line. The fitting is badly dezincified, with a substantial meringue deposit inside the fitting, as well as on the barbs which lie between the fitting and PEX tub.

What is dezincification of yellow brass? It's simply the process of dealloying, with the basic metals separating themselves from the designed alloy. The zinc gets dissolved and depleted, leaving behind a weak, copper-rich porous fitting.

Dezincification occurs when excessive proportions of zinc are used—anything greater than 15 percent is unacceptable. The higher the zinc content, the greater the susceptibility to dezincification. Rather than this article delving into the atomic structure of the metal, and an analysis of alpha and beta brass particles in the duplex brass, what happens is the zinc dissolves out of the metal alloy, leaving behind a porous network of a weak, copper-rich alloy. As it corrodes it often generates a meringue, which is white, often with a greenish tint. The remaining brass then takes on a reddish tint.

The meringue forms outside the fitting as leaks start. It's a sure sign of dezincification. The meringue is not only an indication of a weakening fitting, but also in many circumstances the meringue forms inside the fitting itself, obstructing the waterway and

The only way to remedy the dezincification problem is to remove and replace the yellow brass components, either the fitting or valve itself, or internal yellow brass components if they can be accessed for service.

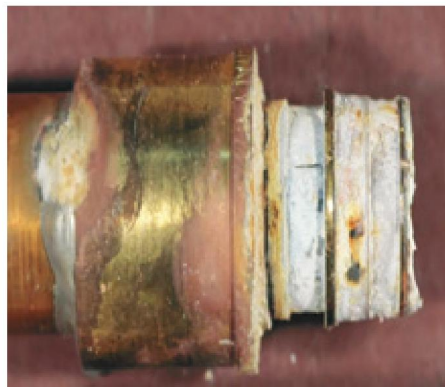
A PEX fitting with the copper water line removed showing corrosion on the barbs and significant deterioration of the fitting itself.
