# HAWAII *hospitality*

LODGING & FOODSERVICE | JULY/AUGUST 2019

# PROTECT *every* STEP

## Somewhere on your property there is an accident waiting to happen

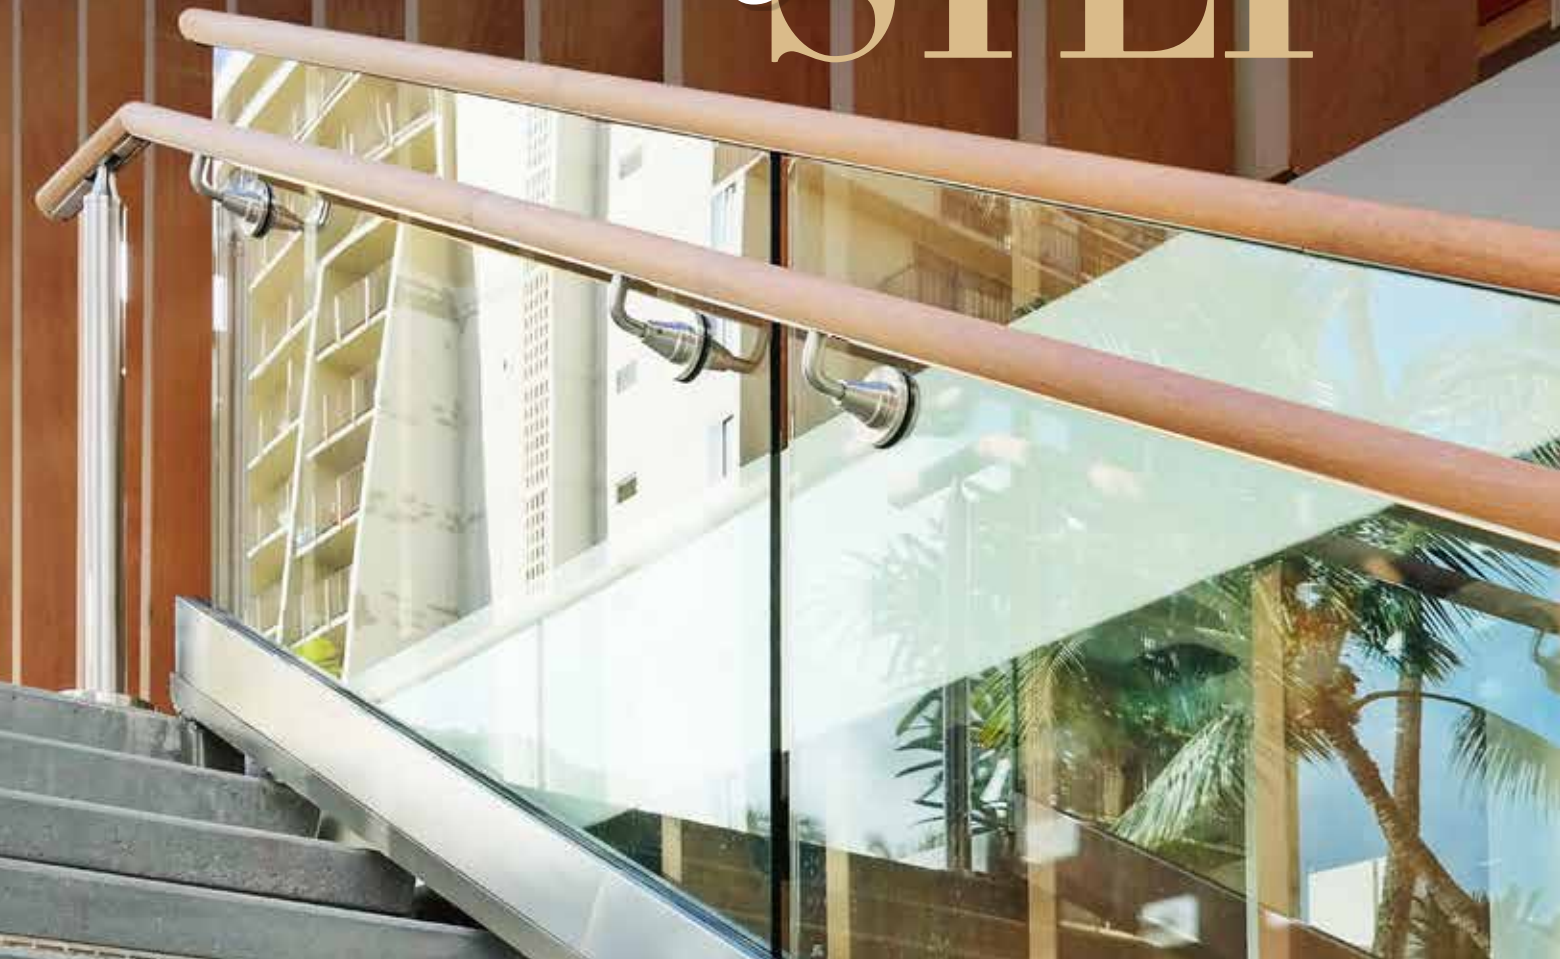
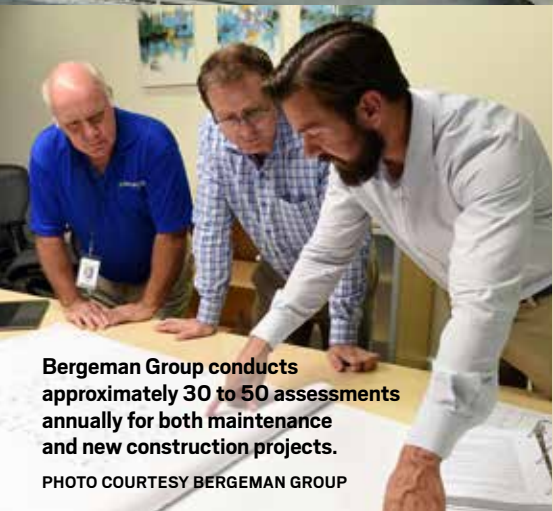
PHOTO COURTESY BERGEMAN GROUP

Bergeman Group conducts approximately 30 to 50 assessments annually for both maintenance and new construction projects.

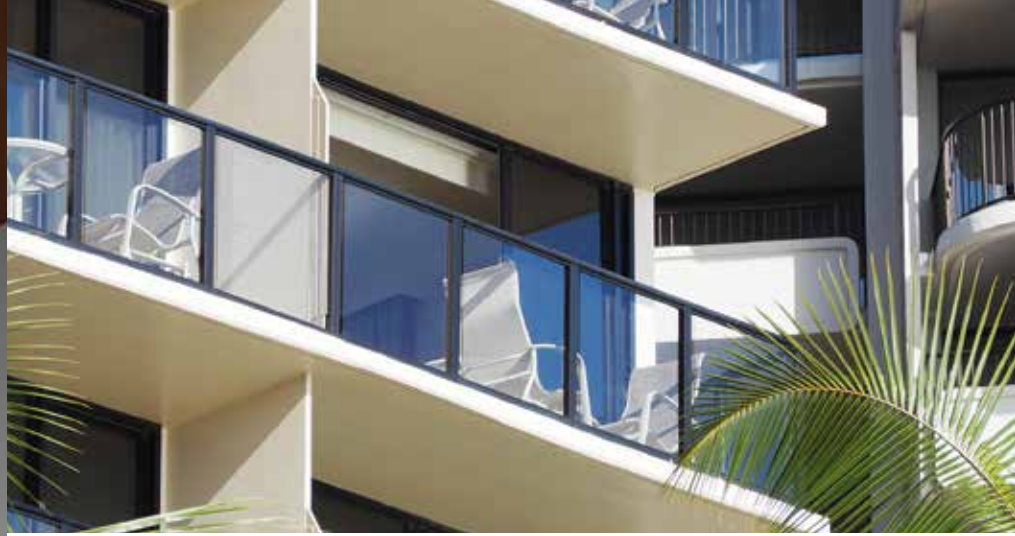
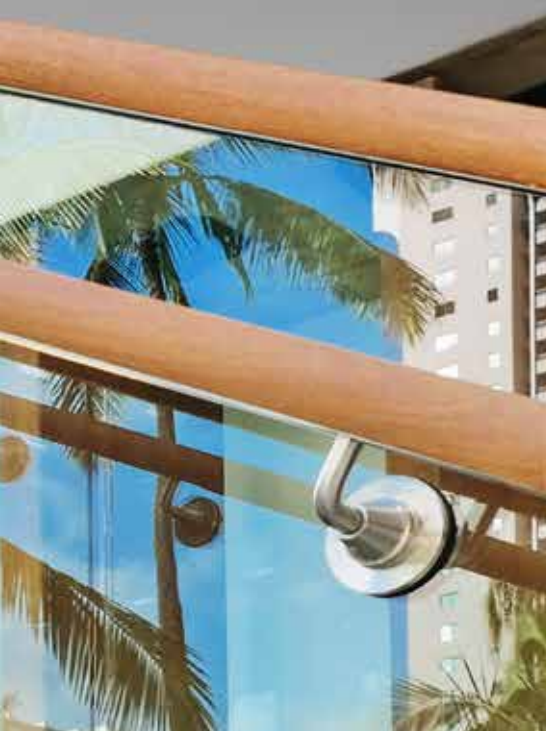
PHOTOS COURTESY ELITE RAILINGS & WINDOWS

Elite Railings installed a frameless glass system (CRL Base shoe system) in 2017 for street and lobby level railings at The Laylow, Autograph Collection. (Right) At the Outrigger Waikiki Beach Resort, Elite Railings used an Elite 1000 series glass railing system on a guestroom replacement project.
